Workshop on Assessment of Existing
Structures

Rehabilitation and seismic upgrading of the Villafranca bridge

Pietro Croce

University of Pisa

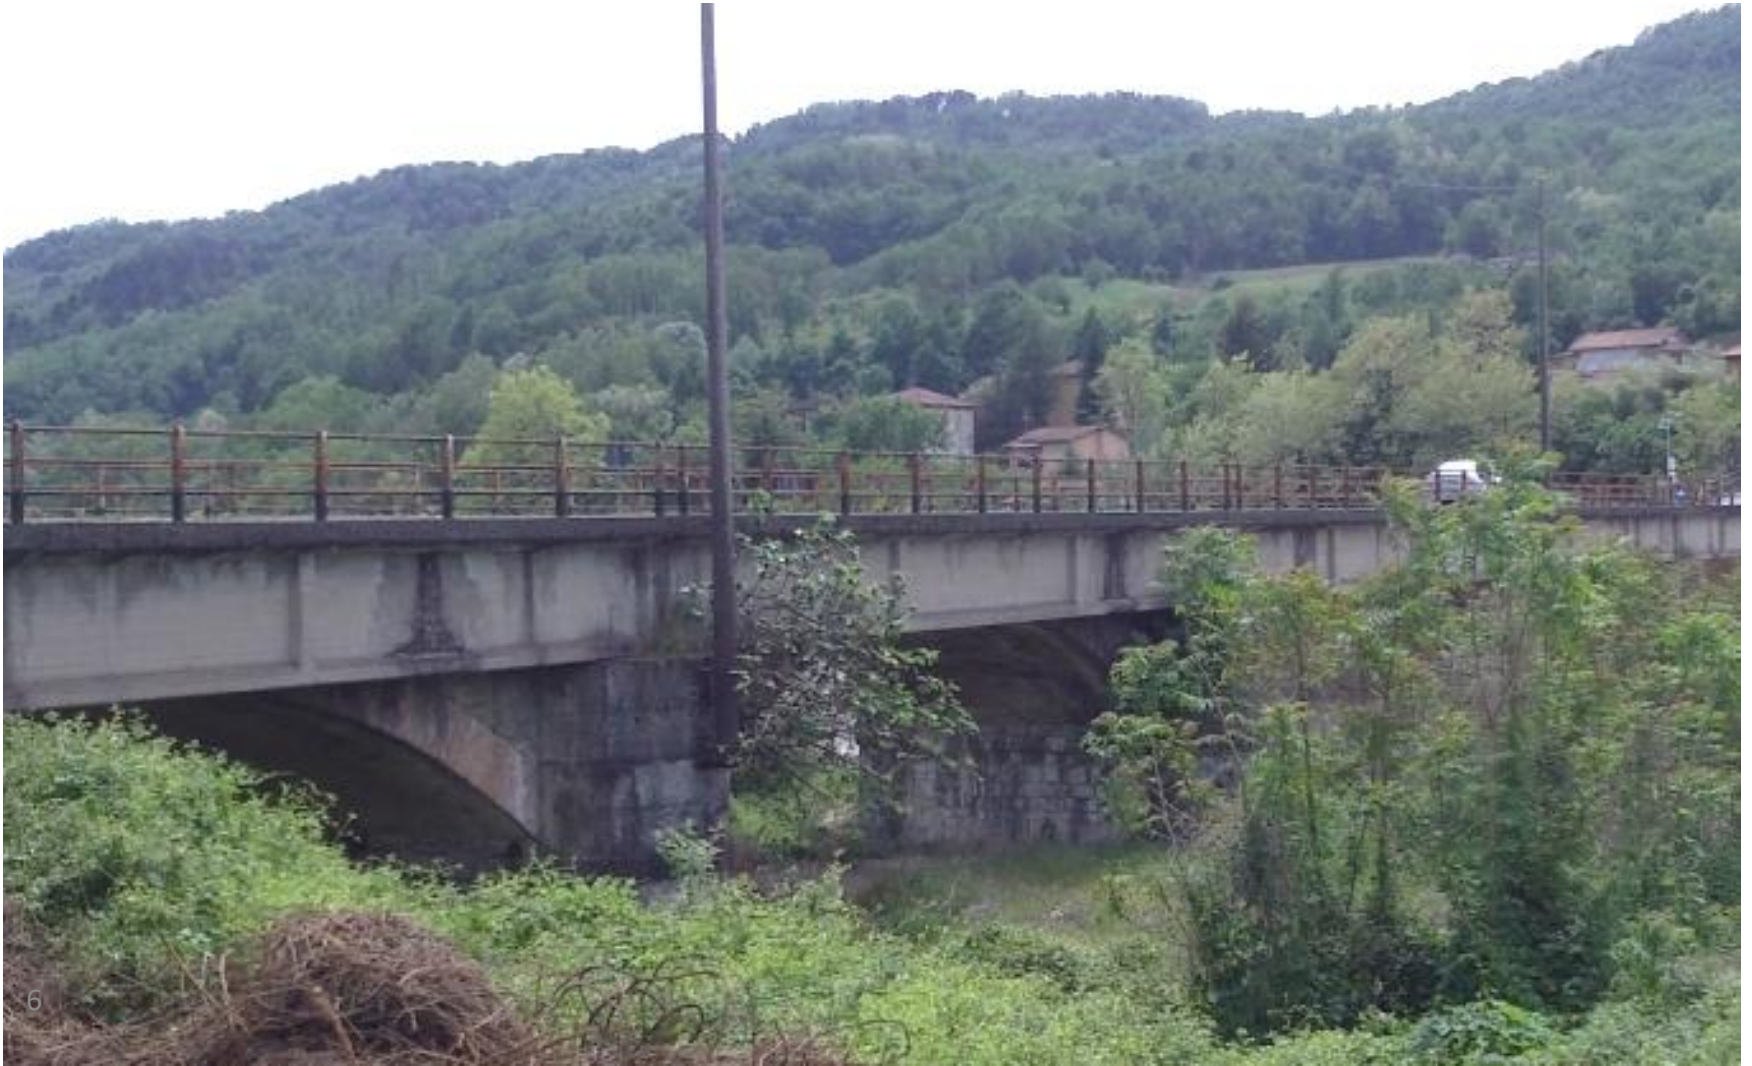
- To carry two lanes, in 1961 carriageway was widened by means of two lateral prestressed concrete beams, hiding the arches and modifying severely the bridge original aspect.

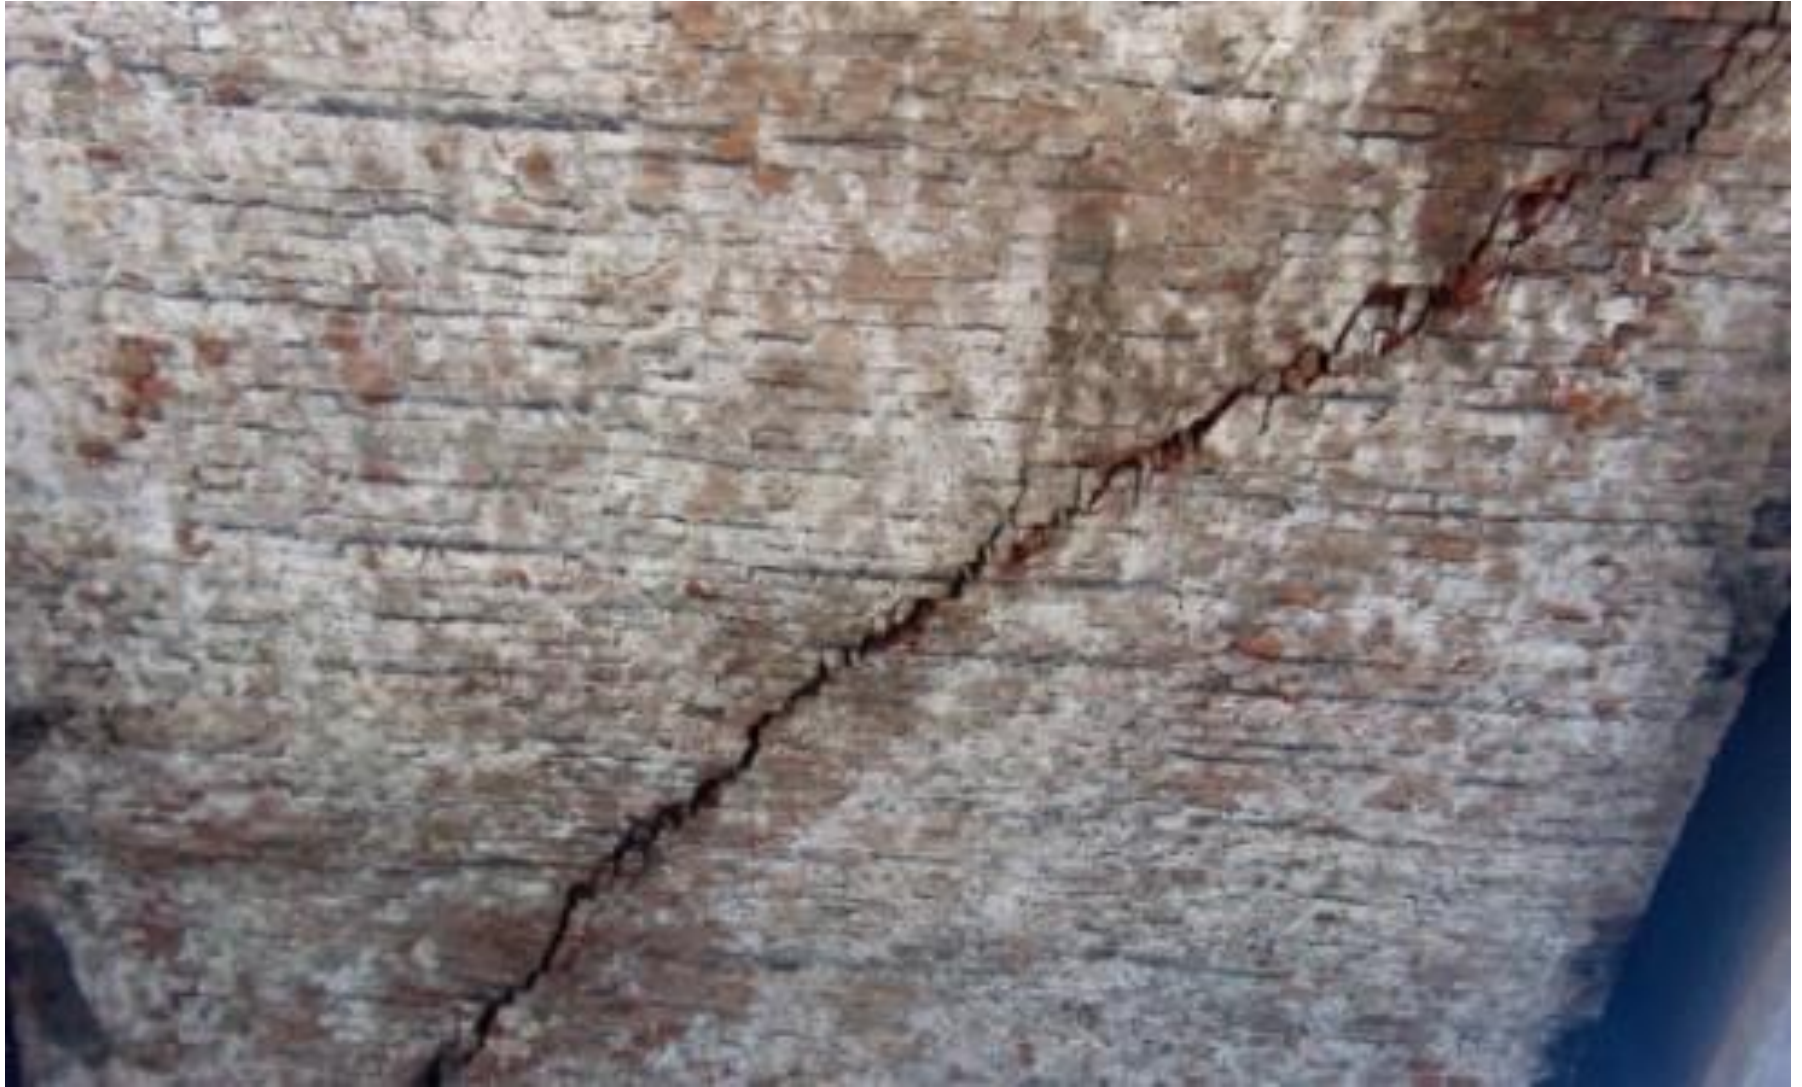
- In 2005-2010 a severe crack pattern appeared in two arches in Mulazzo side, due to scour of the piers

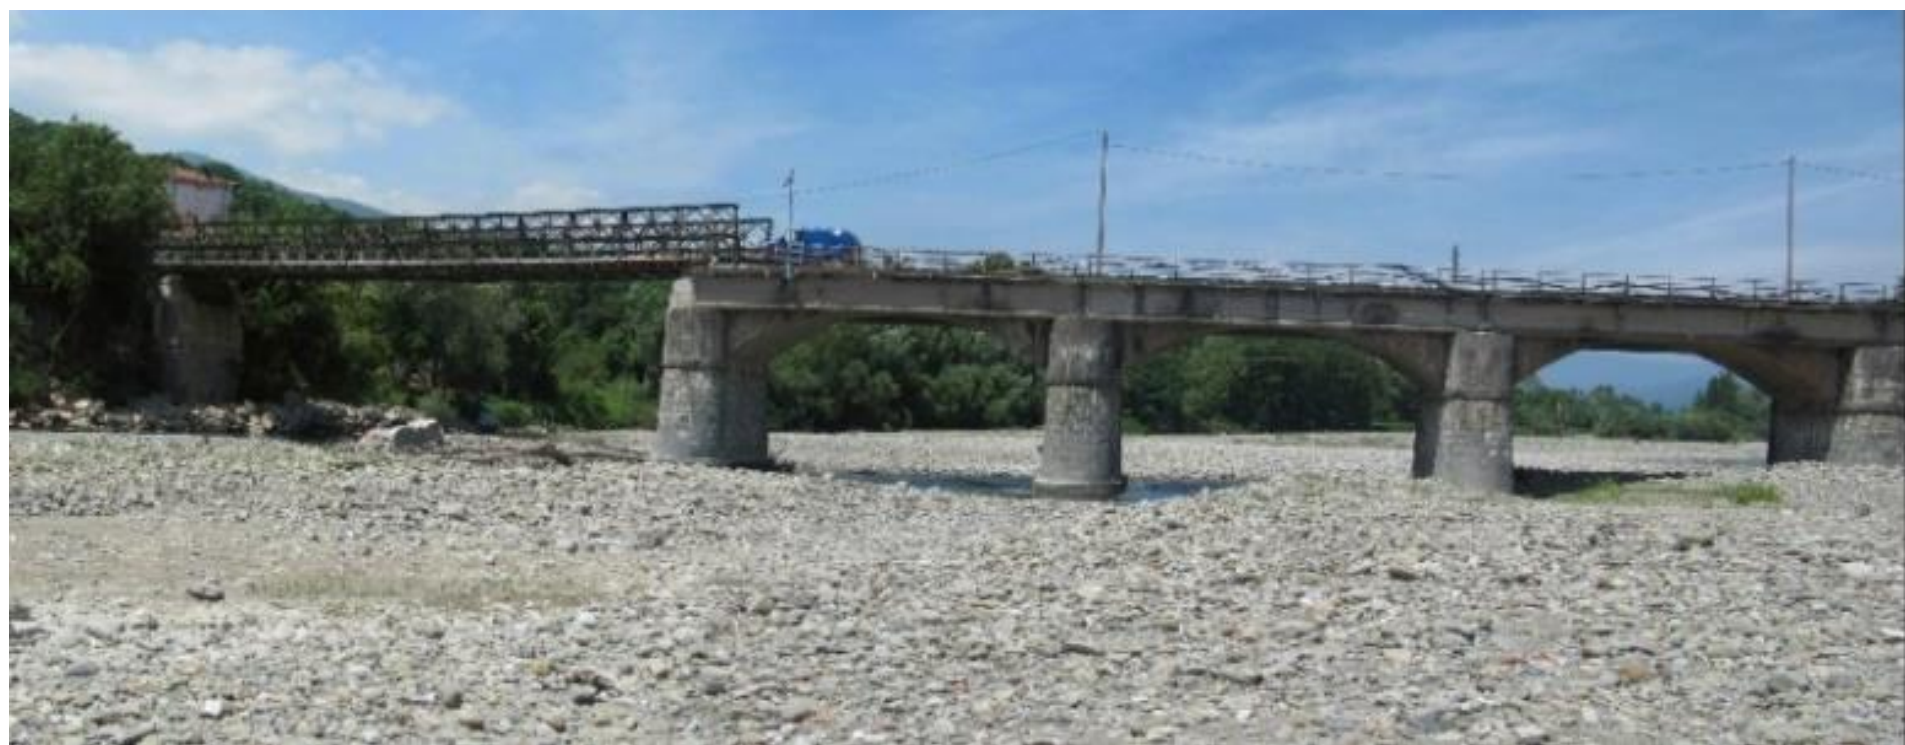
- During the 2011 Magra flooding two arches collapsed
- Light traffic was allowed by a Bailey bridges
