# Troubleshooting Distillation Columns Unexpected Causes for Malfunctioning Columns

Mario Roza, Markus Duss

Sulzer Chemtech Ltd, Winterthur, Switzerland

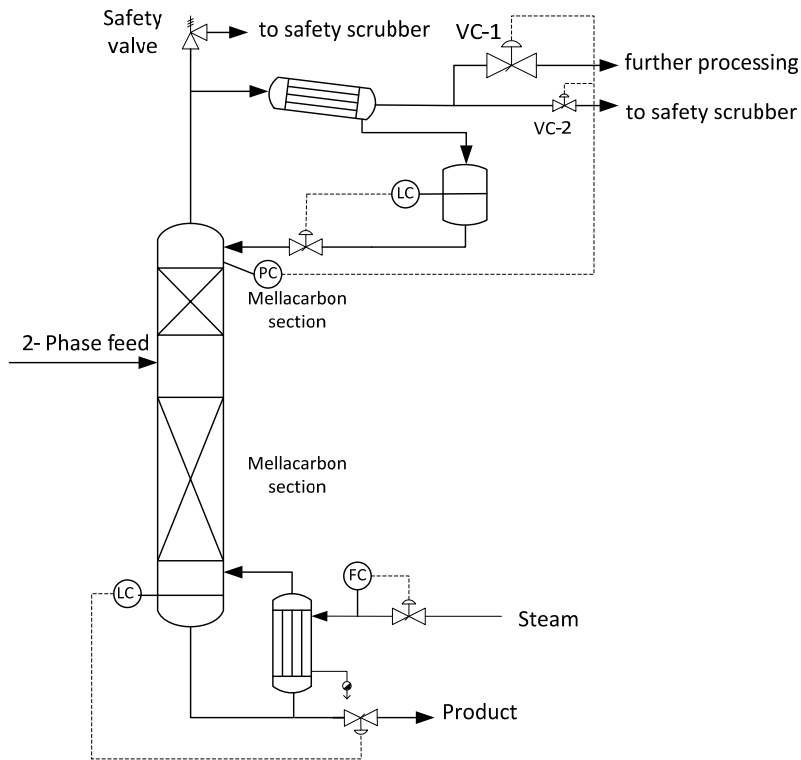
Figure 1: Simplified Process Flow Diagram of the high-pressure column

During the water test, the high-pressure column was started up by opening the steam valve to the reboiler manually with a fixed position. The control valves VC-1 and VC-2 remained closed in manual position, so inert gases in the column were trapped. The temperature of the column sump, filled with water, started to increase due to the steam supply. When the temperature exceeded 100°C, the pressure in the column started to

increase and at 160°C, the pressure was about 6 bar. At 6.5 bar pressure increase the safety valve, which was located up-stream of the condenser, opened. At this point in time the condenser had cooling water supply and was still cold. The inert gas could now leave the column through the safety valve and the inert gas, steam mixture was released through the safety scrubber. However, the condenser down-stream of the safety valve, still filled with trapped inert gas, remained cold. The pressure in the column remained rather stable around 6.5 bar while the safety valve opened and closed intermittently. Based on the DCS records the release through the safety valve continued for a few minutes. The noise of the chattering safety valve made the operators aware of the situation and the control valve to the atmospheric safety scrubber VC-2 was partially opened. Now the inert gas from the condenser was able to escape and inert and steam were released through VC-2 and the column pressure rapidly decreased. This rapid decrease in pressure was partly due to the steam leaving through the control valve but more importantly because of the high condensation rate, as pure steam has an excellent heat transfer coefficient and the temperature difference was high. Based on the recorded liquid level, the initially empty reflux tank was filled within a few seconds. Estimates of the condensation rate indicate that, during this short period, the F-factor must have been extremely high, exceeding 25 Pa<sup>0.5</sup>. At this F-factor, the column was flooding and the pressure drop was so high, that the Mellacarbon packing was lifted up. This uplift might have additionally increased the pressure drop because loosened packing sheets reduced the free area for the gas flowing through the liquid distributors. Consequently, the column internals were also lifted and the observed damages could occur.

The control valve VC-2 to the safety scrubber was designed to restrict flow rates to avoid mechanical damage, even when fully opened. It was the condenser, performing much better than at design conditions, which caused the high F-factors and resulting damage to the internals. The condenser was designed to condense a relative small fraction of liquid from a gaseous phase. The design heat transfer coefficient was small and the transient situation, when pure steam entered a cold condenser, was not considered. To avoid the rapid pressure decrease at startup, the startup procedure was modified. Steam supply to the reboiler required now the pressure control valve VC-2 to be set to automatic mode and the position of the pressure control valve was limited to a minimum value allowing the inert gas to escape. Only when the overhead temperature of column exceeded 100°C, the limitation of the valve position was disabled.

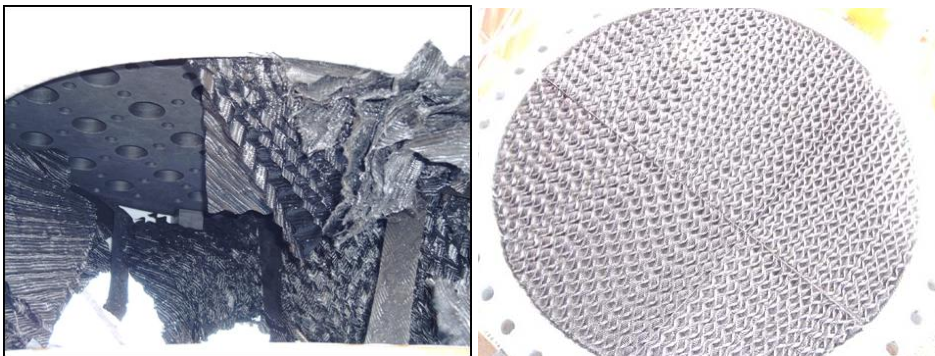
The inspection showed a lot of damage to the bottom carbon fiber bed and some of the graphite internals. The bottom support grid from graphite was broken, but it was still able to support the Mellacarbon packing. The lowest packing layer was destroyed and the 2<sup>nd</sup> layer was severely damaged. Furthermore, the top layer of the bottom bed was destroyed and the second layer damaged. The other layers were still intact. The liquid distributor, a chimney tray with ground holes made from graphite, did not have significant damage, but it had been lifted up and fallen back in position. Some Mellacarbon packing sheets were jammed between the support grid and the distributor, as can be seen in Figure 2. The upper Mellacarbon bed did not show any mechanical damage, however, the liquid distributor at the top had damaged gas raisers and the liquid feed pipe, guiding the reflux into the liquid distributor was torn and heavily damaged.

Figure 2: Left: Chimney tray made of graphite (view from below), with jammed Mellacarbon™ sheets; right: top layer of Mellacarbon™ of the upper section remained in place.

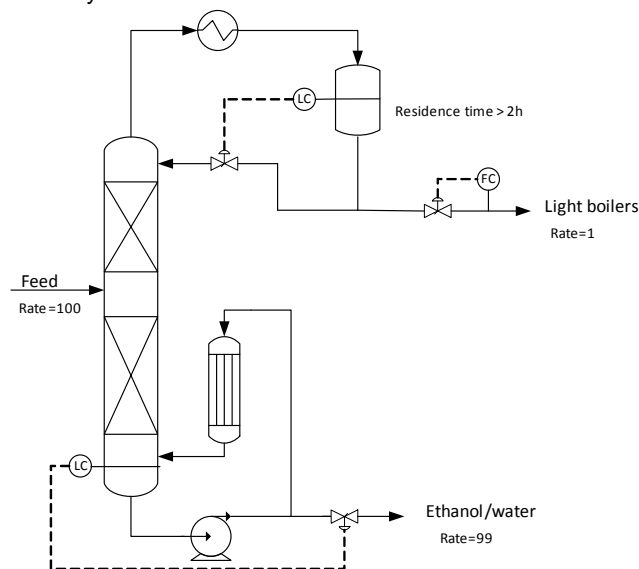
As mentioned before, the first column was fulfilling all expectations, but the second column (Figure 3) did not achieve its performance as expected. The acetaldehyde content was higher than expected and the specification could not be obtained constantly. Particularly, when the column was restarted after a cleaning cycle, the acetaldehyde content was particularly high in the bottom product and exceeded the specification significantly. Only after many hours of continuous operation, the acetaldehyde concentration reached its steady state, close to the required specification.

Figure 3: Simplified Process Flow Diagram of the second column, removing light boilers

Firstly, high residence time in the overhead system: the bleed stream at the top of the column was only about 1% of the feed stream. The overhead system consisted of a condenser with a reflux tank and reflux pump. The reflux was level controlled and the bleed stream was controlled by flow rate (Figure 3). Due to this small bleed stream rate, residence time in the column overhead system was more than 2 hours.

Based on the gained insight, the overall column performance could be significantly improved and the startup time after cleaning cycles reduced. Firstly, the liquid hold-up in the overhead system was reduced. Secondly, the residence time at the bottom was increased. This increased residence time was expected to have a positive effect since a low acetaldehyde concentration would shift the chemical equilibrium and diethyl acetal would decompose to form acetaldehyde, which could be removed from the bottom due to its high relative volatility. In this case, unfortunately not very elegantly, the only practical option to increase residence time was to increase the set point of the level control in the sump closer to the high level alarm.

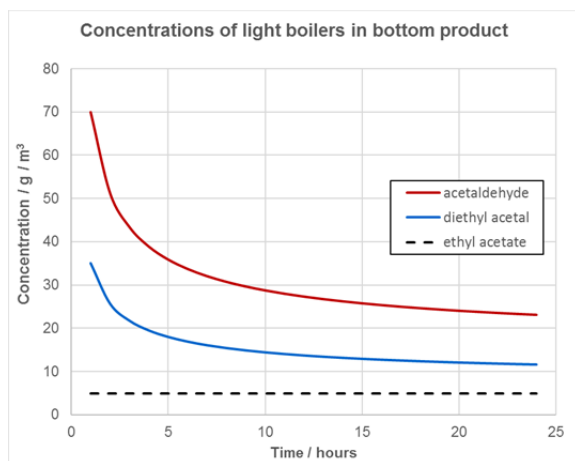
Figure 4: Time dependency of the concentration of relevant light boilers in bottom product stream as measured by the GC.

The results from the GC did not show any unexpected peaks beside acetaldehyde, ethyl acetate and diethyl acetal. However, the ethyl acetate concentration was stable after one hour of operation but acetaldehyde and diethyl acetal concentrations became only stable after about 24 hours. The initial high concentration of acetaldehyde and diethyl acetal in the bottom (main product) after startup was significant and exceeded the required specification by more than a factor of three. It was suspected that acetaldehyde and diethyl acetal underwent reactions during shut-down time. Question is now what reaction could cause that acetaldehyde and diethyl acetal showed such behavior? If acetaldehyde was reacting to form diethyl acetal, one would expect that the acetaldehyde content is low and vice versa, when acetaldehyde was formed from diethyl acetal, then it was expected to find a reduced acetal concentration in the bottom.

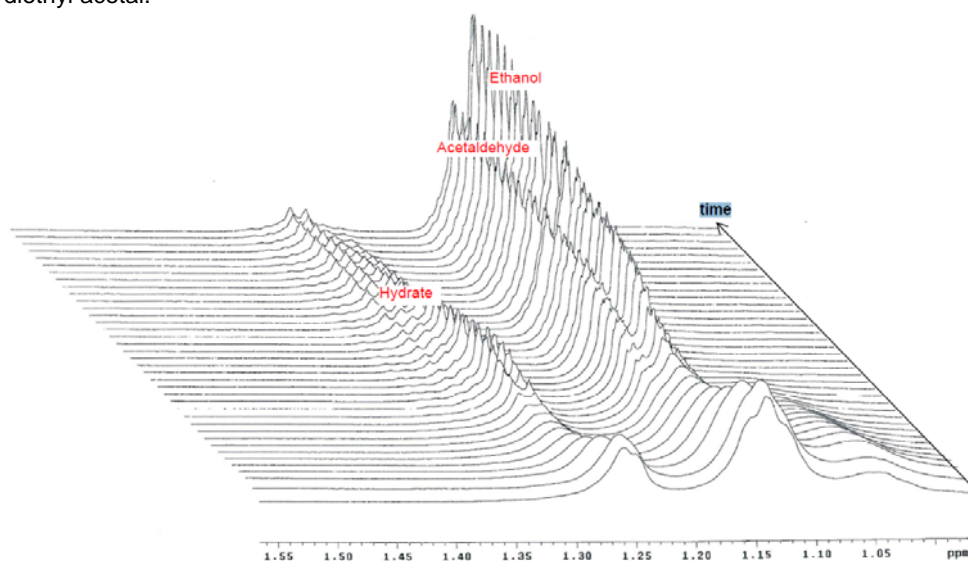
The formation of diethyl acetal came as a surprise since it was expected that the reaction occurred only in presence of acids (Vollhardt, 1990), which act as catalysts. To ensure the reaction takes place also in the presence of water only, the following test was carried out: Pure diethyl acetal was mixed with water, forming two liquid phases. The aqueous phase containing about 5% acetal was analyzed with NMR. The formation of acetaldehyde was monitored for two hours. It was found that the reaction is slow at  $75^\circ\text{C}$ . The concentration in acetaldehyde continuously increased, however equilibrium was not fully achieved after 2 hours. In addition, in a separate test it was shown that acetaldehyde mixed with pure ethanol only forms the hemiacetal and no diethyl acetal.

Figure 5:  $^1\text{H}$ -NMR results showing formation of acetaldehyde and ethanol for a time span of 2 hours, starting from an aqueous phase saturated with diethyl acetal, with no initial ethanol or acetaldehyde.
