DIAGNOSTICS OF HIGH PRESSURE DEPROPANIZER

Lowell Pless¹, Christopher McKeown² and Simon Xu²

Abstract

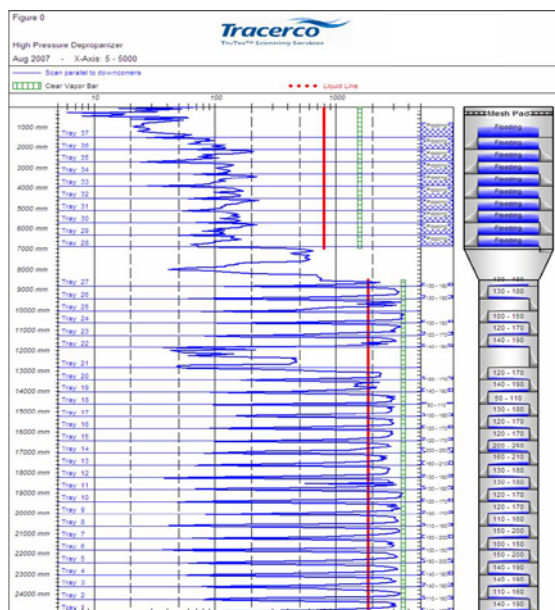
Based on the process data above it seemed obvious that the top section of trays in the HP Depropanizer was flooding. Rigorous checks of plant operating data versus simulation calculations showed no major deviations from the process design. A gamma scan was performed to confirm the flooding, as well as to see where the flooding was originating. The gamma scan confirmed that the top section of the HP Depropanizer was flooding. As seen in Figure 2 the flooding started at Tray 28 indicating that the downflow liquid from Tray 28 was restricted at the transition zone. However the initial scan could not provide sufficient information to answer the questions on the root cause of flooding:

Figure 2. Initial Scan Showed that Flooding Started at Tray 28.

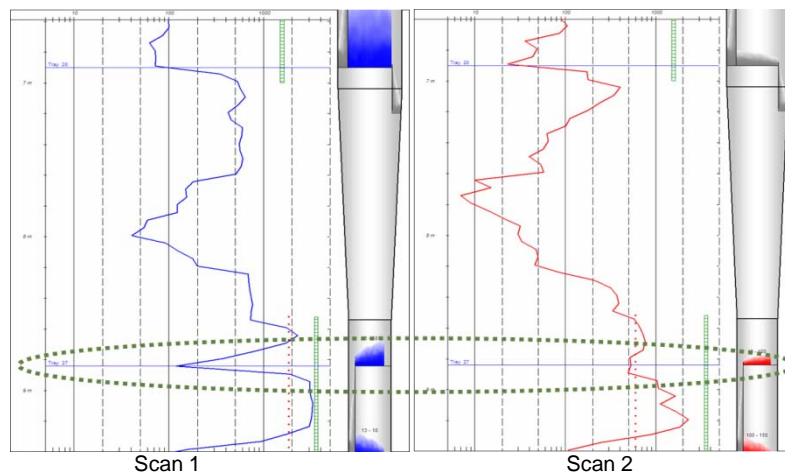
Figure 4 is an expanded view of the two scans through the transition section. While the orientation of Scan 2 was not perfect for investigating the hydraulic condition of Tray 28's downcomer it did reveal some new information. Scan 1 showed a level of aerated liquid on Tray 27 while Scan 2 showed Tray 27 operating dry, as seen in Figure 4. Within the highlighted area on Figure 4 Scan 1 (the blue curve) showed a response at Tray 27 signifying some dense material (liquid) on the active area of Tray 27. Conversely Scan 2 (red curve) within the highlighted area showed nearly no response at Tray 27. There was no dense material i.e., no liquid holding on Tray 27. Since Tray 27 had been seen holding liquid there was no question that Tray 27 was intact mechanically and capable of holding liquid. Instead during the operation when Scan 2 was performed, while the flooding persisted Tray 27 had gone dry, presumably because liquid downflow from Tray 28 above was severely restricted.

Figure 4. The Liquid Holdup or Froth on Tray 27 Appeared Unsteady During the Scans

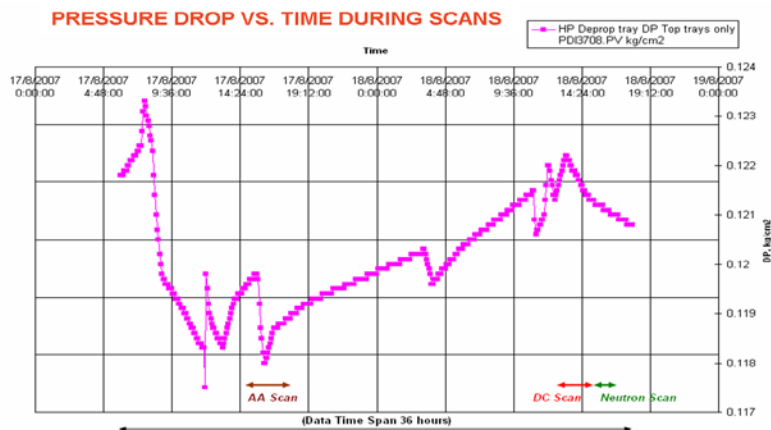
Reconciling these results with plant process data (Figure 5) showed that as the pressure drop or flooding severity increased and prolonged, Tray 27 dried up again confirming that the downcomer from Tray 28 was restricted.

Figure 4. Pressure Drops (Indication of Flooding Severity) during the Scans

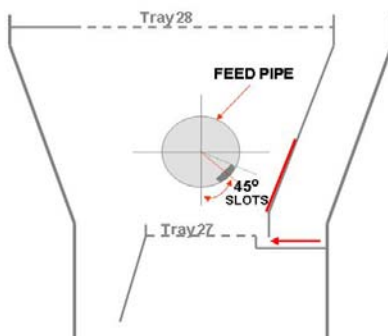
Figure 6. Questionable Tower Internals in the Transition Section

The process simulation showed a mixed phase feed of approximately 93 wt% vapor and 7 wt% liquid (vol% of liquid in the feed < 0.25%). The 2-phase pipe distributor was designed for the exit slots to be centered at an angle of 60° from vertical. Unfortunately some construction drawings showed that the pipe distributor was installed with the exit slots centered 45° from vertical. Therefore, incoming feed was being directed towards the bottom of Tray 28 downcomer. The downcomer from the top section (Tray 28) had been sized based on the liquid load in the middle section of the tower rather than the liquid load coming from the top section. For this reason the downcomer through the transition area was oversized. Because of this the liquid head in the downcomer was lower than expected and gave some concern that the liquid seal could be lost allowing vapor feed to travel up the downcomer. A second goal from the scanning activity was to try to determine if this vapor-bypassing was happening.

An impingement plate is typically used on the downcomer apron to act as a heat insulator to avoid downcomer liquid from being vaporized by the warm feed. In this design the feed temperature was only 3°C (5°F) warmer than the downcomer liquid so the impingement baffle had been left off. In reality the actual temperature profile may not be exactly as predicted by simulation models, as process turbulences could cause temperature deviations. An impingement plate should be installed as an extra precaution.

Evidence was accumulating that vapor flow from the feed was going up the downcomer from Tray 28. At this point everyone involved, especially plant management, wanted “proof-positive” that the hypothesis of vapor-bypassing up Tray 28’s downcomer was actually happening.

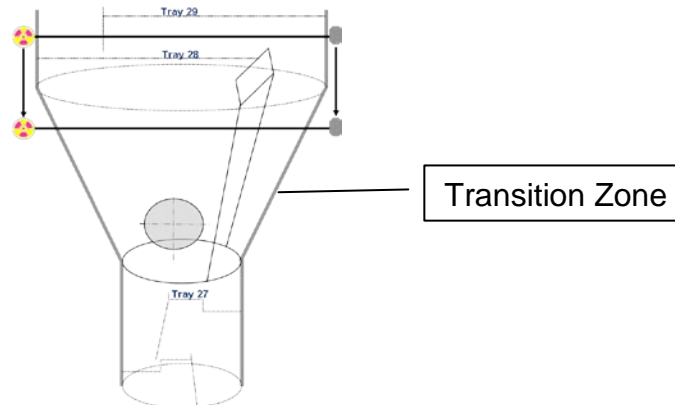
Under most circumstances gamma scanning through tray downcomers is the recommended approach. However there were some extraordinary reasons why this was not the best approach in the circumstance of this HP Depropanizer. The physical structure of the HP Depropanizer, top large diameter and bottom smaller diameter, is challenging for gamma scanning, as shown in Figure 7. As the gamma source and detector travel down through the transition zone, the source and detector are essentially hanging “in the air”, instead of maintaining contact against the walls. Due to limited access through the transition zone this was unavoidable on this tower. Additionally the diameter is constantly changing through the transition zone. Even if one was able to keep the source and detector up against the column wall, for each drop in elevation the radiation counts at the detector will vary based on the constantly changing diameter. It could be possible, even if improbable, that a change in internal process density would be negated or exaggerated by the change in diameter or distance from source to detector.

Figure 7. The Transition Section Imposed Challenges to Gamma Scans

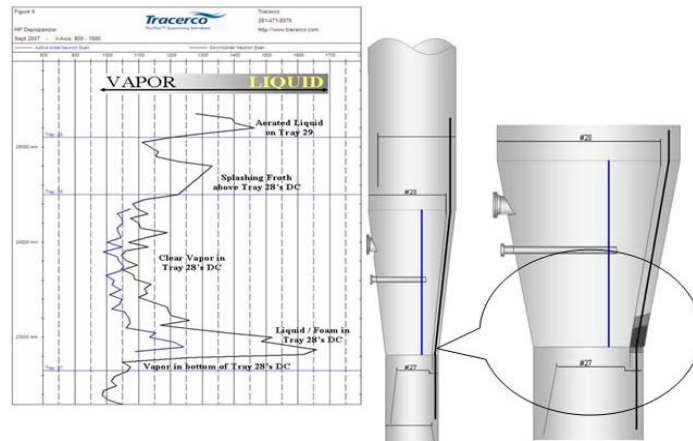
The best approach to scan through the downcomer in the transition zone would be to scan with neutrons. Neutrons essentially measure the hydrogen concentration of the material in front of the neutron source/detector apparatus. In this case we would expect a large response where hydrocarbon liquid was present and a smaller response where vapor or less liquid was present. The neutron scan started above the opening of Tray 28’s downcomer and proceeded down to below the bottom of this downcomer. The black curve in Figure 8 shows the results from this scan. At the bottom of the downcomer where one would expect liquid the neutron response instead showed vapor. There was a “liquid” response further up in the downcomer, several centimeters from the bottom. The belief is this was a layer of highly aerated liquid or foam suspended in the downcomer by the vapor. Furthermore at the same time neutron readings were taken on the active area of Tray 27 and it was seen to be void of any substantial level of liquid. Thus the neutron scans validated the hypothesis of vapor was blowing back up Tray 28’s downcomer and preventing liquid from down-flowing out of the top section, thus flooding the top of the HP Depropanizer.

Figure 8. Neutron Scans of the Downcomer in Transition Section
Active Area Scan in BLUE; Downcomer Scan in BLACK

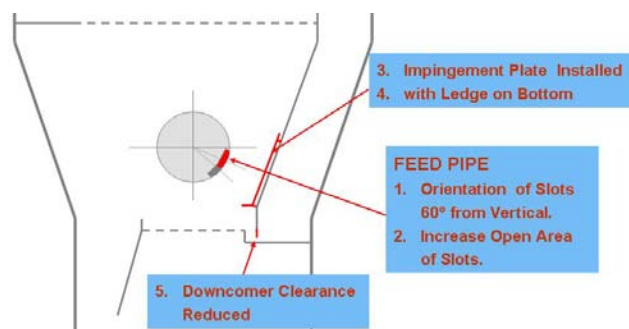
Figure 9. Modifications of the HP Depropanizer Transition Zone

With a clear picture on the root cause of flooding in the transition section, several steps were proposed and installed to correct the configuration of the HP Depropanizer feed zone (refer to Figure 9):

- First, the feed pipe slots were modified to be 60° from vertical, reducing the probability of vapor blowing directly onto the downcomer outlet,
- Second, the slot open area was increased to reduce the vapor exit velocity,
- Third, an impingement plate was added to the downcomer apron to provide insulation between the hot vapor and cooler liquid to minimize downcomer liquid vaporizing,
- Fourth, the impingement plate had a ledge added to its bottom edge to further guard against the vapor impinging down onto the liquid leaving the downcomer,
- Fifth, the under downcomer clearance (UDC) was reduced in order to increase the liquid head in the downcomer to secure a liquid seal at the bottom of the downcomer.

It could be argued that not all of the above design changes were necessary to correct this flooding issue. However, all the changes recommended were low-cost and due to the importance of this tower every opportunity to improve the design was taken to ensure success following the plant shutdown. After these modifications were installed the HP Depropanizer and the unit were restarted. The unit was able to demonstrate design capacity in a successful plant test run with no further symptoms of flooding.
