# STABILITY PROBLEMS AND ROCK SUPPORT AT THE TELLNES OPEN PIT MINE, NORWAY

Bjørn Nilsen, Professor Norwegian University of Science and Technology (NTNU) / SINTEF Rock and Soil Mechanics and Brian J. Ballou, P.E. Mine Manager Titania A/S

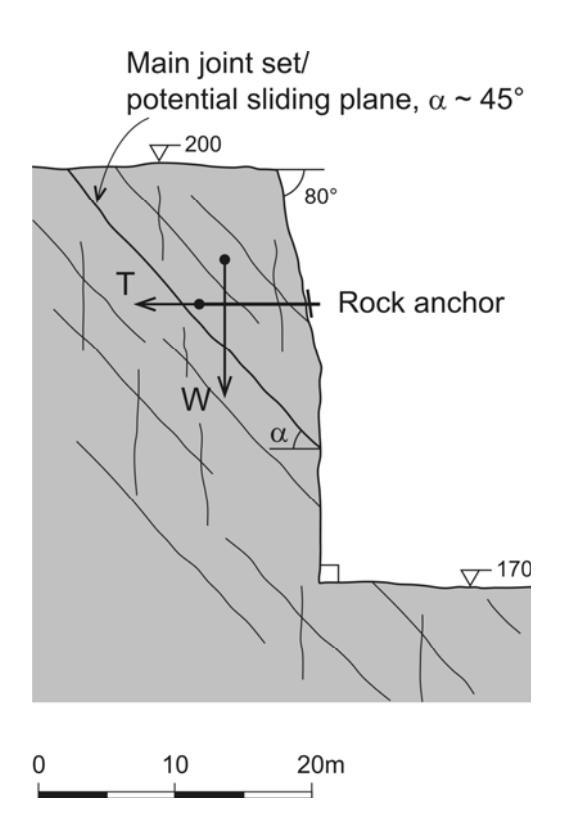
The hanging wall area (southern side) is the area of the mine, which has experienced the most frequent and the most serious stability problems. The general problem here, as previously mentioned, is that very distinct, continuous joints, often containing significant amounts of clay gouge, are oriented with strike approximately parallel to the pit wall and with intermediate dip towards the bottom of the pit, thus representing a risk for plane failure between the benches as illustrated in Figure 3. Typical strike of such joints is N115- 160°E, and the dip is typically 40-50°NE (with around 45° as the most common).

The dip angle is very close to critical angle for sliding, and since cross joints releasing potential sliding volumes at the sides are quite common, bench stability problems due to sliding has been a recurring problem in the hanging wall. Installation of rock bolts as spot bolting therefore was introduced early in particularly difficult areas. Based on some unexpected incidents of sliding, systematic bolting in difficult areas has been introduced more recently.

*Figure 3. Principle sketch of bench stability problem due to undercutting joints in the hanging wall.*

The basis for design of bolt pattern is systematical, continuous joint mapping and estimation of required anchoring force (T) based on the assumption that the volume prior to support is in the state of unstable equilibrium, i.e. the factor of safety FS~1.0. The estimation is based on standard pit wall geometry; i.e. 30 m between benches,  $80^{\circ}$  wall angle the first 15 m and  $90^{\circ}$  wall the next 15 m. The volume undercut by the joint is calculated for alternative locations of potential sliding plane, including the worst case scenario; i.e. undercutting joint starting from just above the foot of the wall, and for alternative dip angles.

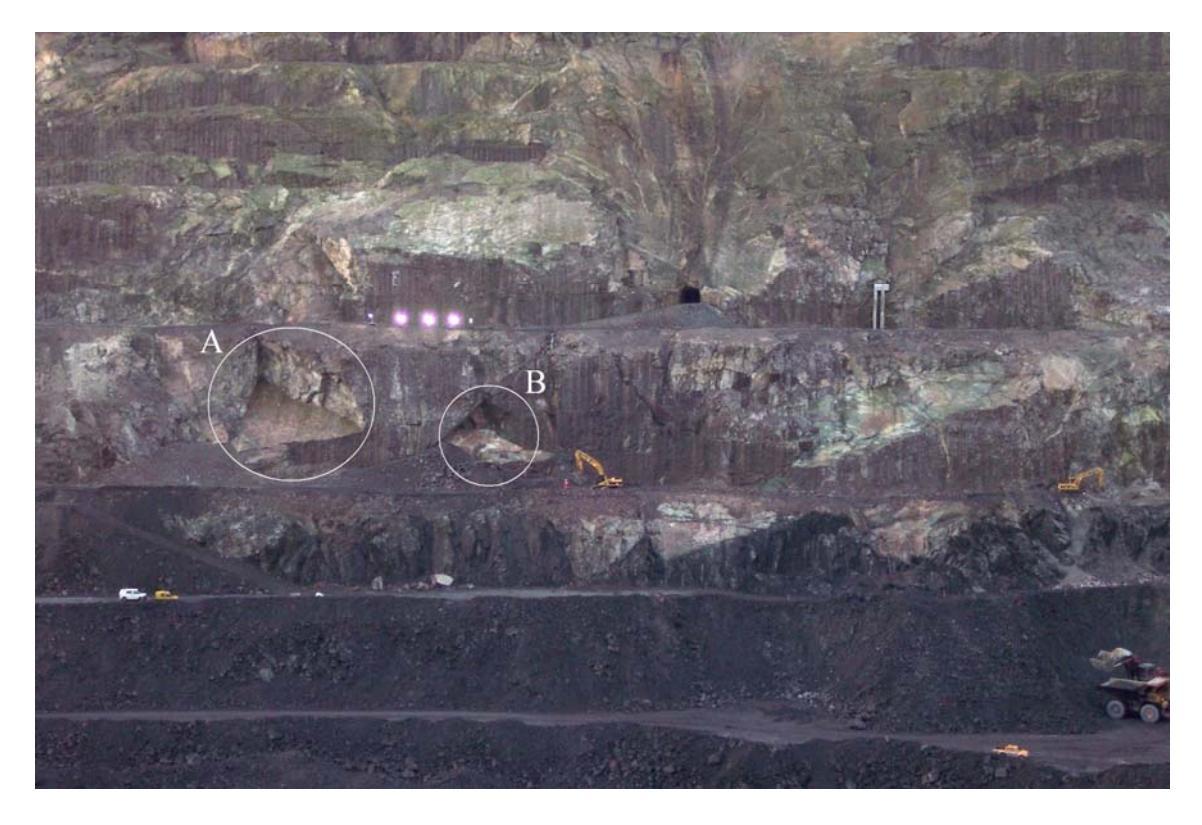
*Figure 4. Overview of the central part of the hanging wall, characterized by distinct, undercutting joints.*

As shown on Figure 4, the very distinct, undercutting joints have caused sliding of considerable tonnage (A~1000 tonnes and B~200 tonnes) before it was possible to install rock support. The incidents at A and B on the photo occurred during production blasting, and before the final wall was established. Still, incidents like these illustrate the importance of continuous joint mapping and installing the required support in time. In practice, this is often difficult since the daylighting of critical joints will not be visible before the final wall has been established. Alternative support methodology by installing bundles of 6-9 rebar bolts in boreholes drilled from above and parallel to the pit wall therefore has been evaluated (Nilsen & Hagen, 1990), but so far has not been used in the hanging wall (although as of January 2006 is being designed). As will be discussed in the next chapter, this approach has been used with good results for stabilizing an unstable area above the main transport road in the footwall.

The extent of rock anchoring having been carried out in the hanging wall varies with geology from no bolting in some areas to systematical bolting with relatively close spacing in other areas. Mainly, 12 m long, diameter 32 mm rebar bolts have been applied. In some areas, like between A-B and to the right of B in Figure 4, bundles of 3 bolts have been installed in each borehole, with average borehole-spacing of ~1.5 m (zigzag pattern).

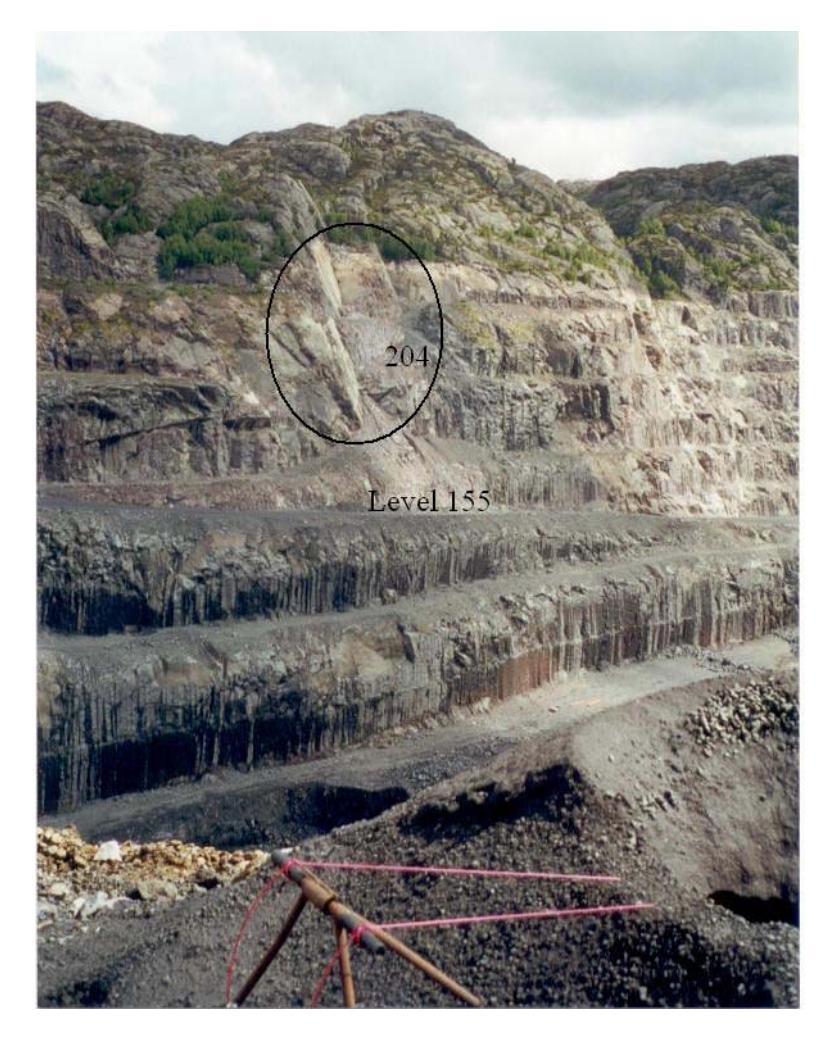
One of the most serious incidents in the footwall occurred during a period of very heavy rain in August 1997, when wedge failure of about 5,000 tonnes took place. As shown in Figure 5, the failure was located just above the main transport road (level 155), and was caused by unfavorably oriented, distinct joints filled with clay minerals and chlorite (N70°E/64°SE and N170°E/50°W, respectively, measured as orientations for Western and Eastern, undercutting joint).

Figure 5. Slide area above the main transport road in the footwall, profile 1150 (photo taken from SW).

The main transport road in this area is at level approx. 155. The upper limit of the slide was at level 184, and the material from the estimated 5,000 tonne slide completely covered the bench at level 170. As can be seen on Figure 5, the very distinct joint to the West can be followed all the way from the top to the bottom of the pit, and the stability of this part of the mine, the area above the main transport road included, therefore was considered to be highly questionable.

In principle, two alternatives were considered possible for solving this problem; rock support or removal of the unstable volume by blasting. Removal of the entire unstable volume was considered to represent a very comprehensive and risky operation, and even if successfully carried out, would give an unfavorable geometry with protruding corners in parts of the wall. It was therefore concluded that a combination of rock support and minor trimming would be the best alternative.

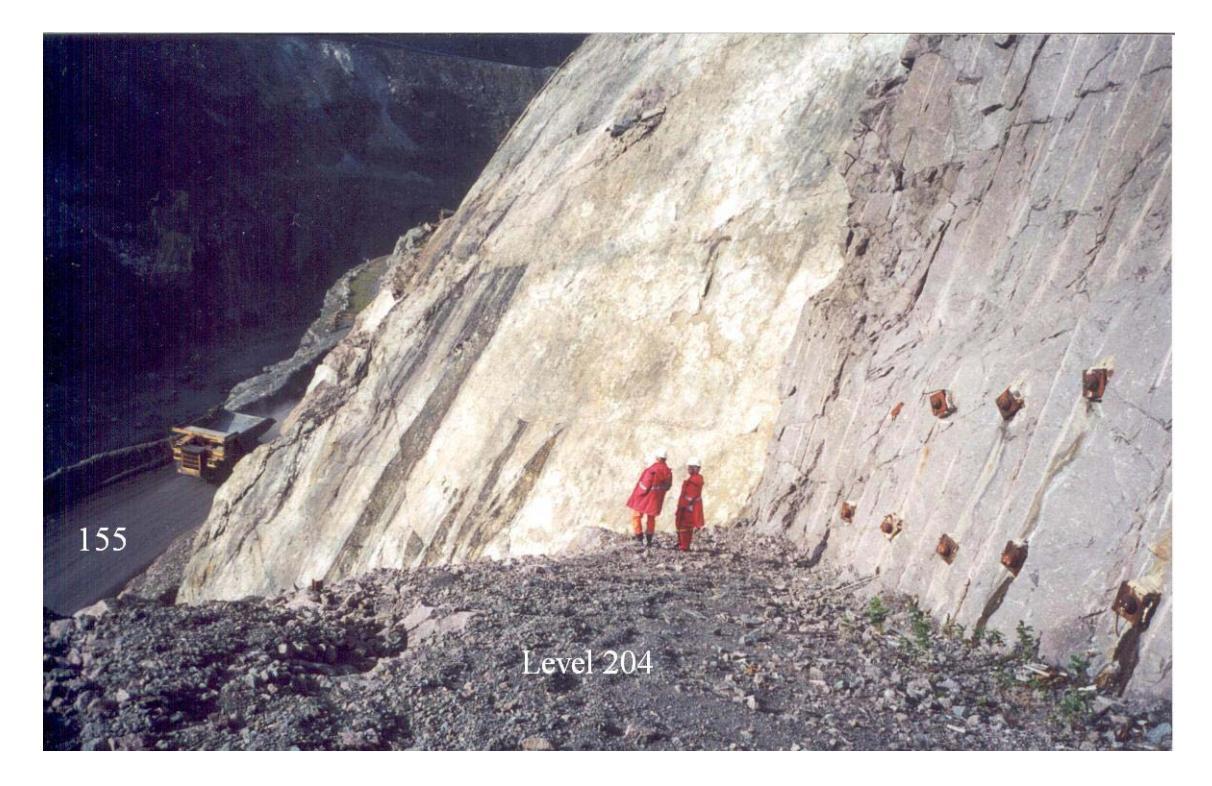
Figure 6. Support of footwall after wedge failure above main transport road.

- Anchoring of the estimated 14,000 tonne wedge above level 204 with 150 tonne, tensioned rock anchors installed in slightly upwards-inclined drillholes. Based upon similar design principle as described in Chapter 3 and a safety factor of 1.3, a total number of 10 rock anchors, 10-25 m in length were installed.
- 2) Support of the estimated 3,600 tonne wedge below level 204 was carried out with bundles of rebar steel in vertical boreholes as described at the end of Chapter 3. Based on shear capacity of rebar estimated to be approximately equal with the tensile capacity, 6 bundles of 10-20 m long rebar steel, each consisting of 5 diameter 32 mm rebar and representing a capacity of 150 tonne, were installed.
- 3) Drilling of drainage holes, inclined slightly upwards.
- 4) Careful trimming of the outer/protruding part of the volume below level 204.

The reason for the different approaches of supporting the volumes above and below level 204 was that access was possible for installing ~horizontal anchors in the former,

but not in the latter area. The support, including the somewhat unconventional approach for the volume below level 204, has functioned well, and no stability problems have been experienced after support was installed.

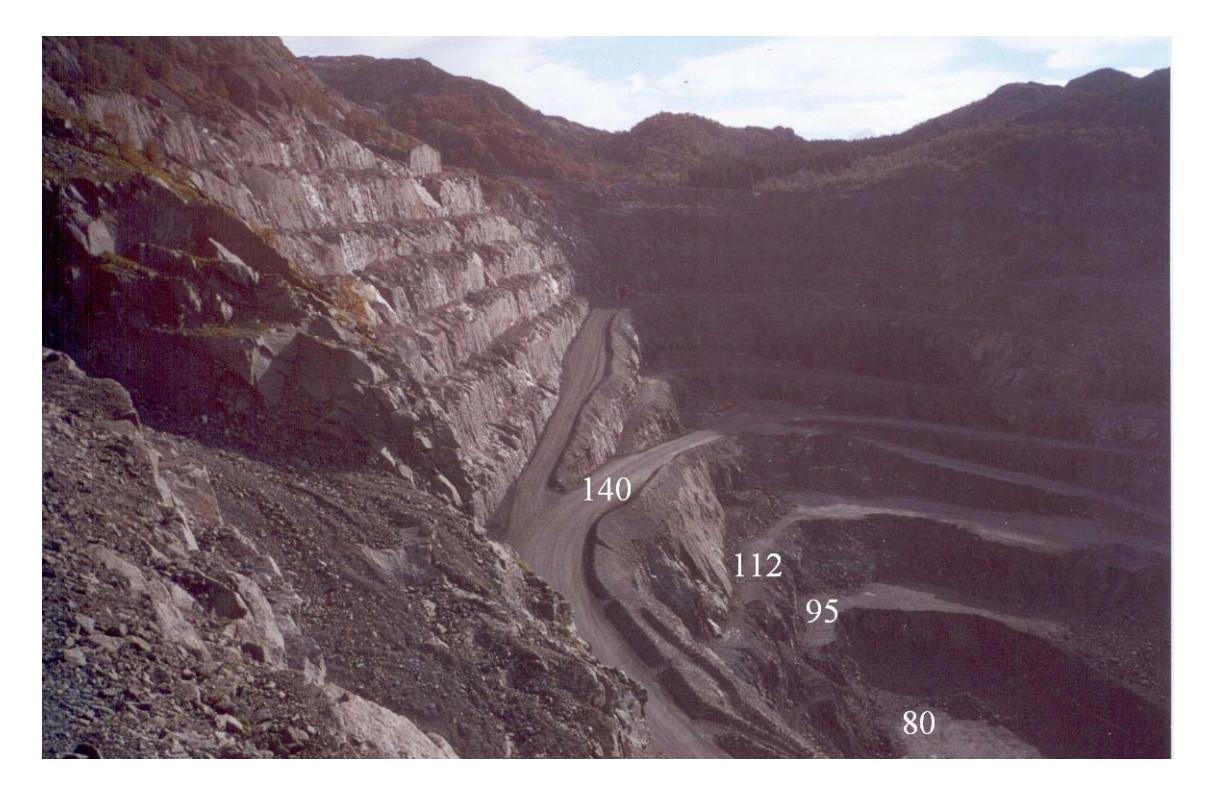
Nearby the area discussed above, a little further to the East and below the main transport road, a very distinct clay-filled joint caused problems in 2001-2002. As shown in Figure 7, a very distinct joint is here oriented approximately parallel with the pit wall (strike/dip approximately N135°E/57°SW). The joint has a filling of clay minerals and obviously may represent the sliding plane of a potential large-scale plane failure if undercut. As shown on Figure 7, the pit wall follows this joint from the main transport road at level 140 to level 112, and it is obvious that the joint continues further down.

The undercutting joint caused stability problems resulting in some narrowing of the road as can be seen on Figure 7, and to prevent further sliding that would cause unacceptable narrowing, quite comprehensive rock anchoring was carried out of the wall between level 140 and 112.

*Figure 7. The footwall at the Eastern part of Tellnes open pit mine as seen in October 2002. The main transport road is at level 140 and the bottom of the pit at level 80.*

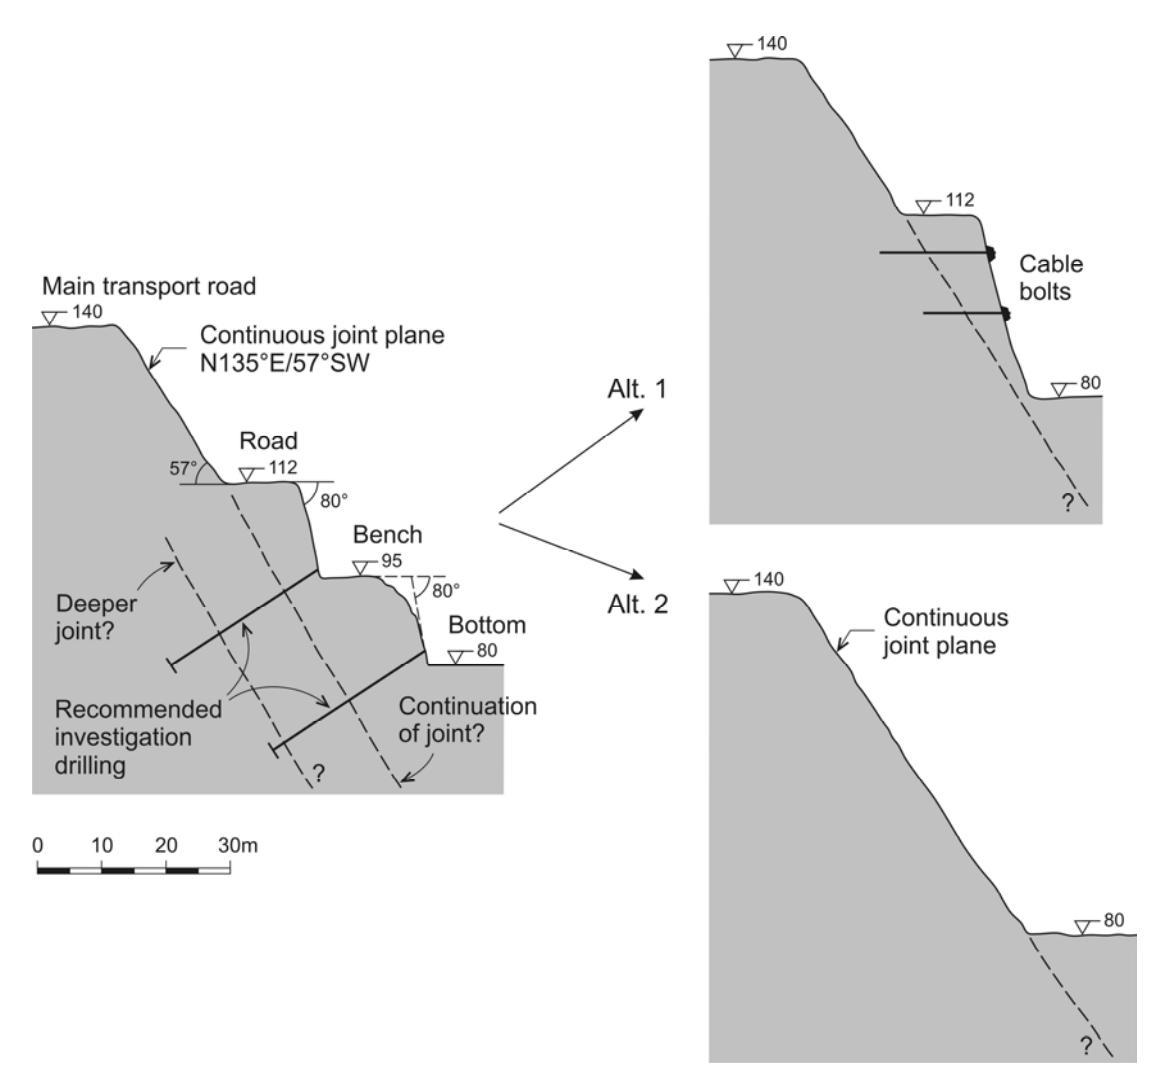
Instead of excavating directly from level 112 to level 80, risking damage of the toe of the bench, a 15 m wide bench at level 95 was established, giving a 13 m wide foot as illustrated in Figure 8.

Figure 8. Cross section of the temporary pit wall below the main transport road shown in Figure 7, and the two alternatives for final wall design between level 140 and 80 (right).

1) Attempting to support the wall between level 112 and 80 by using rock anchors, giving "ordinary wall design" as shown in Figure 8, top right.

2) Letting the final wall follow the distinct joint all the way from level 140 to level 80, as shown in Figure 8, bottom right.

Based on overall evaluation of safety, feasibility and cost, alternative 2) was concluded to be the best solution. The main reason for choosing alternative 2) was that the rock mass was considered to be heavily fractured and that considerable displacement had already taken place. Rock anchoring similar to the layout illustrated in Figure 6 (above level 204 was therefore considered difficult in practice.

Based on this, the pit was designed by following the distinct joint all the way from level 140 to level 80, which proved to give a stable final wall in this area.
