# STABILITY PROBLEMS AND ROCK SUPPORT AT THE TELLNES OPEN PIT MINE, NORWAY

Bjørn Nilsen, Professor Norwegian University of Science and Technology (NTNU) / SINTEF Rock and Soil Mechanics and Brian J. Ballou, P.E. Mine Manager Titania A/S

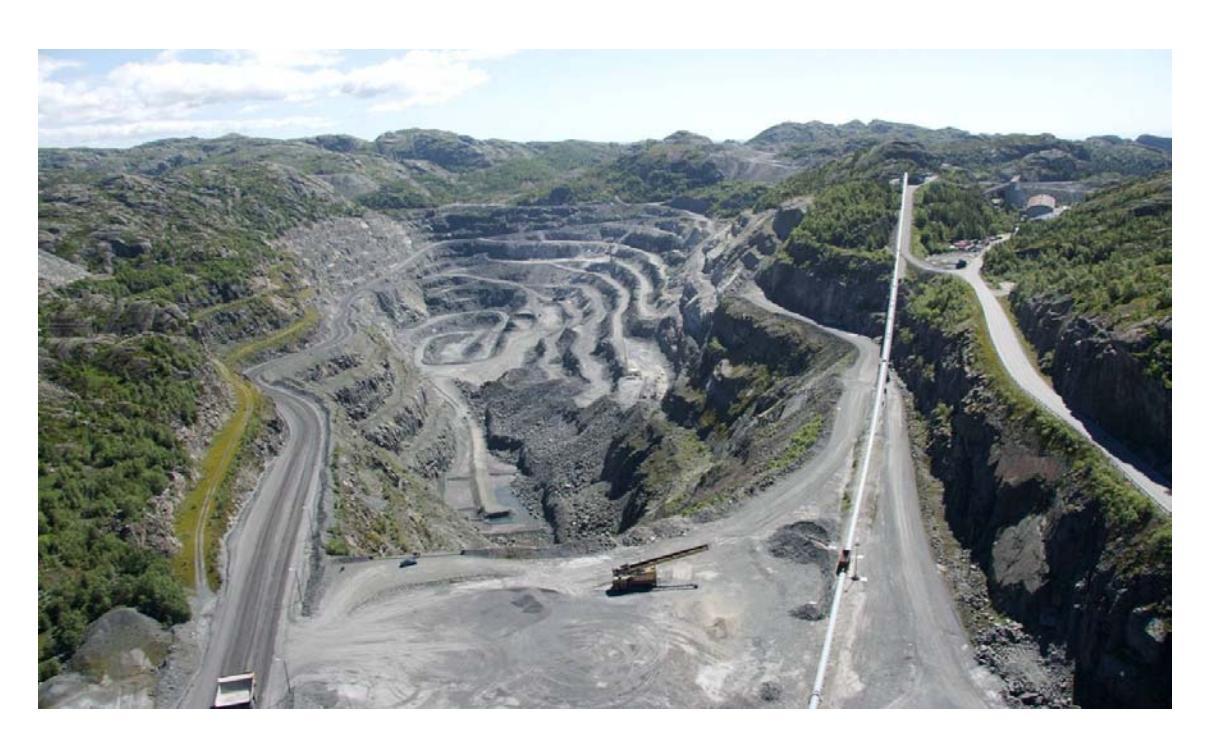
Figure 2. Tellnes open pit mine seen from West. Hanging wall (SW) to the right, footwall (NE) to the left. The top of the footwall is here at level  $\sim$ 250 m and the bottom is at level  $\sim$ 80 m.

The final pit slope at Tellnes has a bench height of 15 meters and a bench for every 30 meters giving an overall slope angle of approximately 55°. The maximum height of pit walls is currently about 150 meters with the current mine plan extending this distance to 400 meters. Figure 2 gives an overview of the mine as seen from the West in June 2005.

For contour blasting, pre-splitting with 32 mm pipe charges in 2.5" holes is used. As can be seen in Figure 2 and 5, this gives good results when the geological conditions are favorable (mainly in the footwall). In the hanging wall, as can be seen in Figure 4, smooth walls are considerably more difficult to obtain.
