Workshop on Assessment of Existing
Structures

Rehabilitation and seismic upgrading of the Villafranca bridge

Pietro Croce

University of Pisa

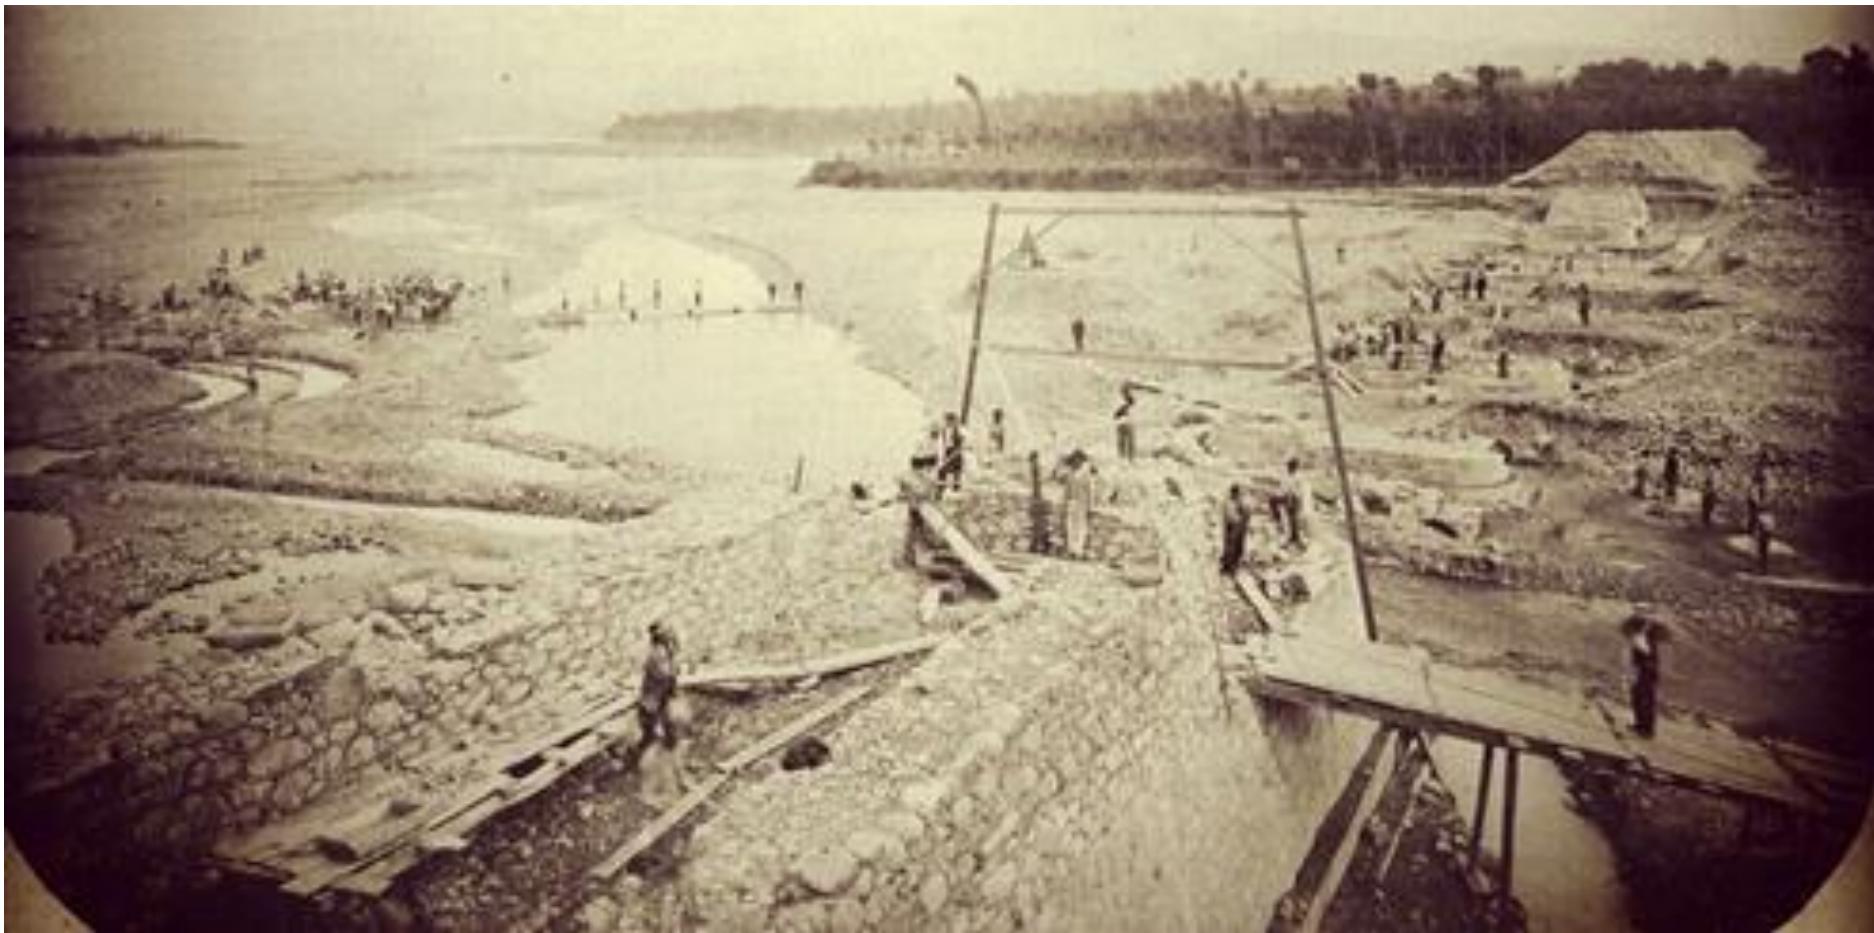
The bridge during the erection phase

- In 1874 the course of the river was slightly different; the bridge was on a right bend (velocity of the current higher on Villafranca side (left bank))

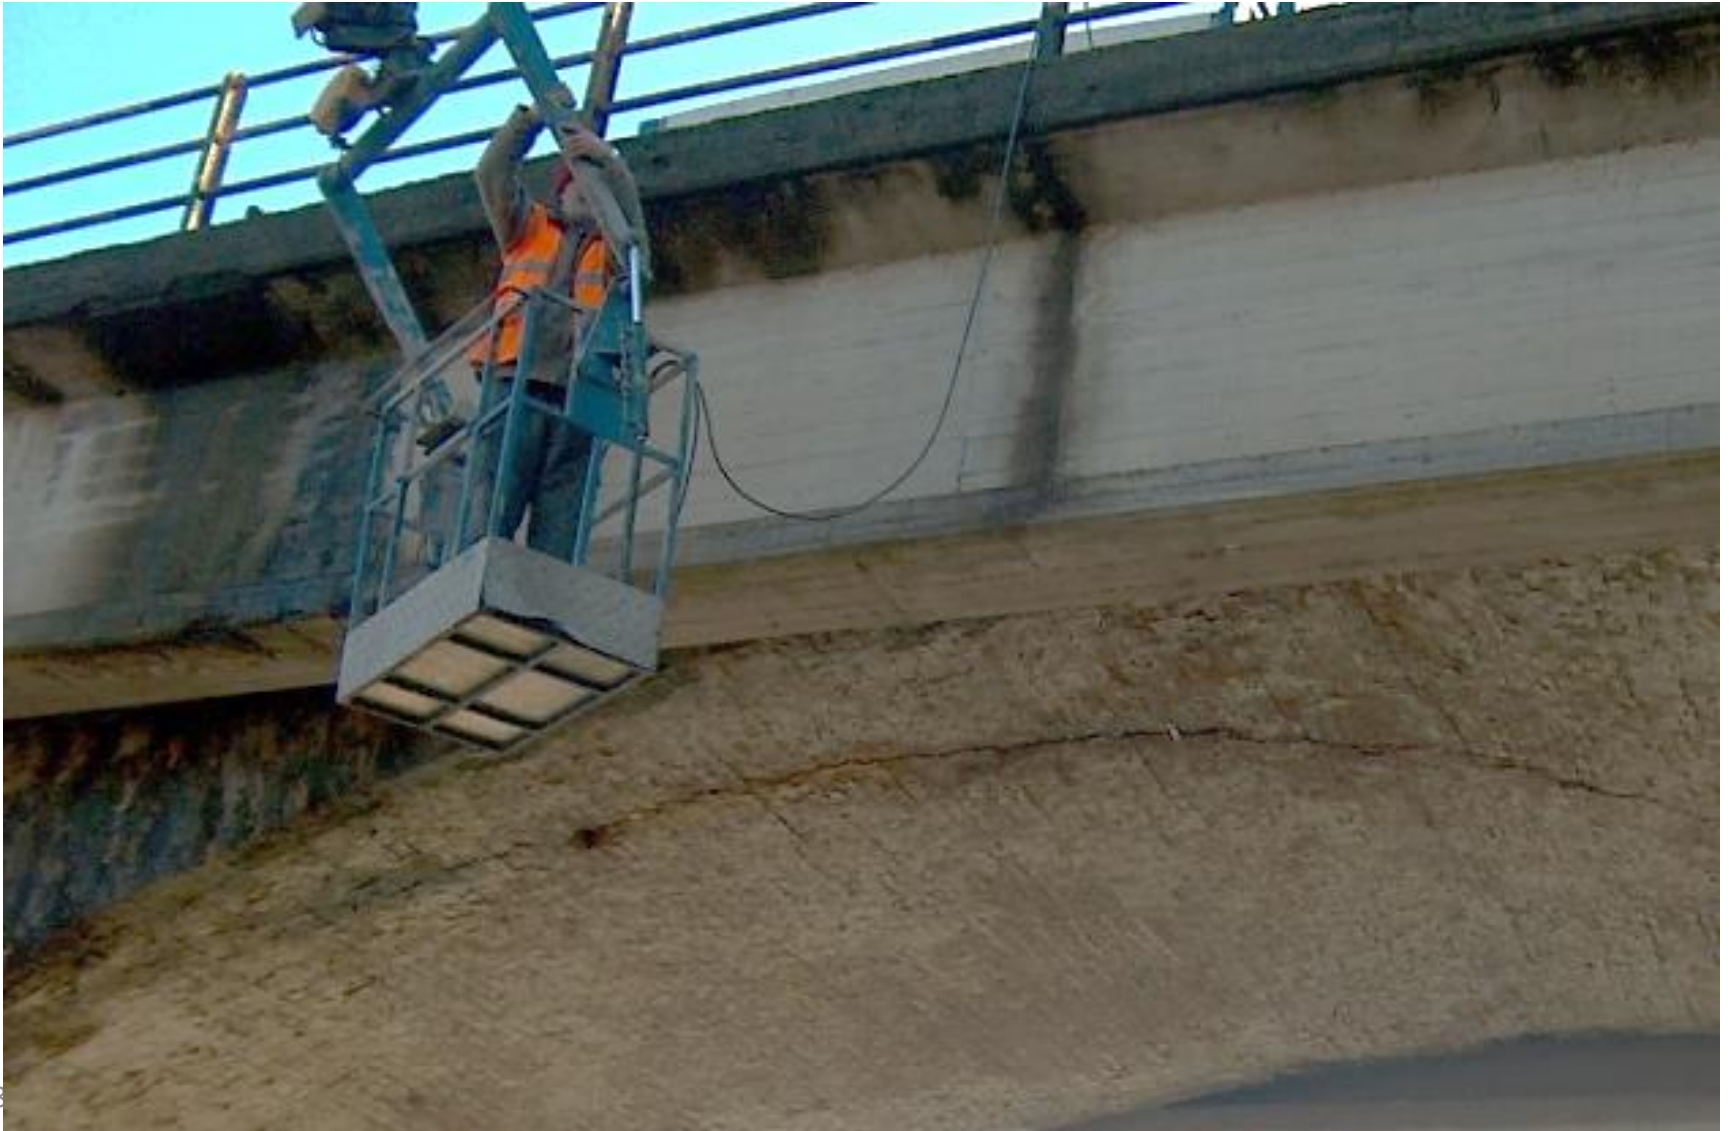
- Monitoring and inspection programme
