DIAGNOSTICS OF HIGH PRESSURE DEPROPANIZER

Lowell Pless¹, Christopher McKeown² and Simon Xu²

Abstract

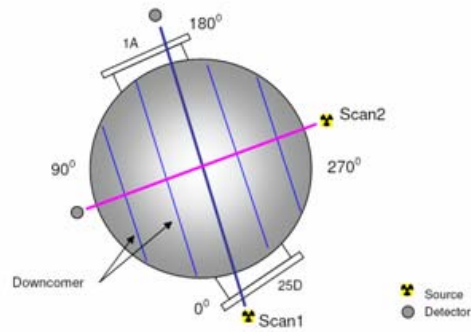
Figure 3. Scan Line Orientations

To investigate the hydraulic abnormalities in the transition zone, two more gamma scans were performed, one for active areas and one for downcomers, as shown in Figure 3. Scan 1 was performed across the active area by scanning parallel to the downcomer; Scan 2 was perpendicular through the downcomer.
